SMA-8300 /SMA-4750 FIRMWARE RELEASE V3871

Overview

This document describes how to update the SMA amplifier firmware using the PC web client.

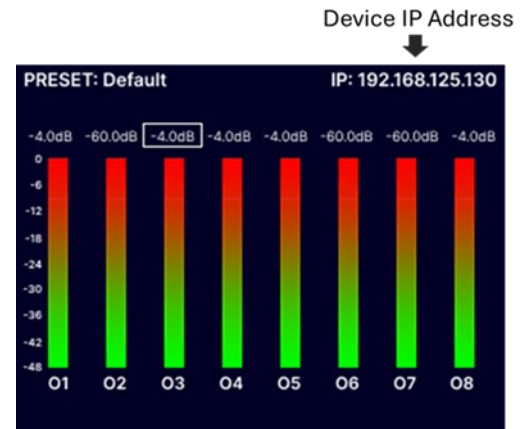
1. Open a web browser on your PC.
2. Locate the IP address of the unit using the front panel display as shown to the right.
3. Type the IP address of the unit in the browser address bar and press "Enter."
4. The browser should display the Web user interface.

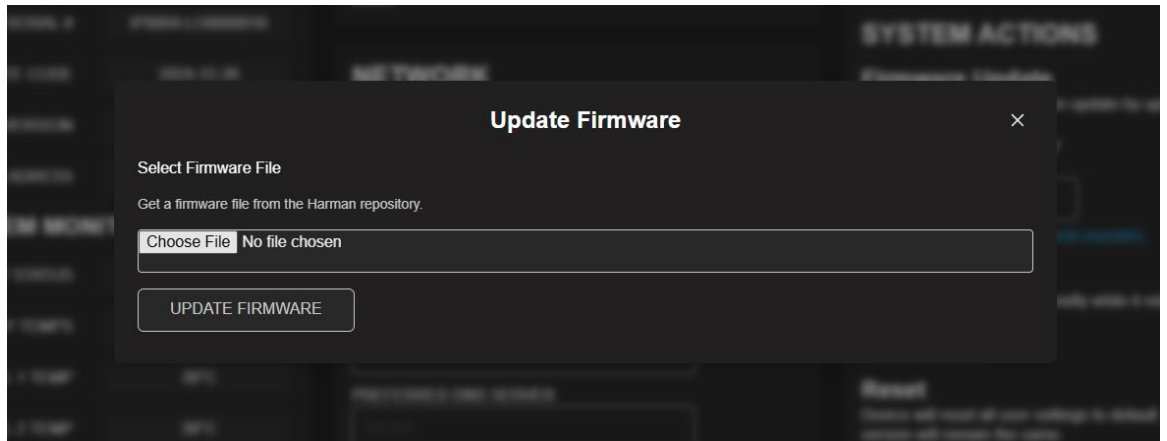
Click to choose a FW update file

1. Click “Get a firmware file from the Harman repository”
2. Download the latest firmware update file to your computer
3. Click the “FIRMWARE UPDATE” button
4. Click “Choose File”
5. Select the downloaded firmware file (the extension will be “.swu”)
6. Click “UPDATE FIRMWARE” to begin the update process
7. The amplifier’s front panel display will show the firmware update progress bar move from 0% to 100% over a period of 1-2 minutes
8. Allow the amplifier to automatically reboot.
9. Once the process is complete, reconnect to the web client to verify the Firmware version has been updated.

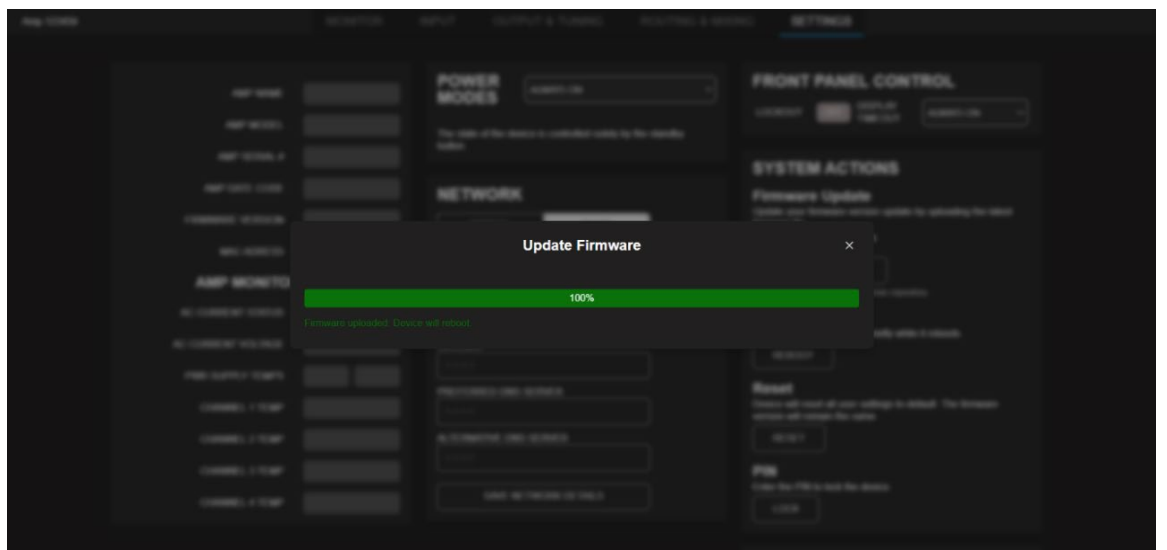
Update Progress bar shows firmware upload is complete

NOTE: The amplifier's front panel display will show the actual firmware update progress. Allow the amplifier to automatically reboot.
